York adds big hole to pipe woes

Unstable ground makes repair work challenging

No quick fix for sinkhole

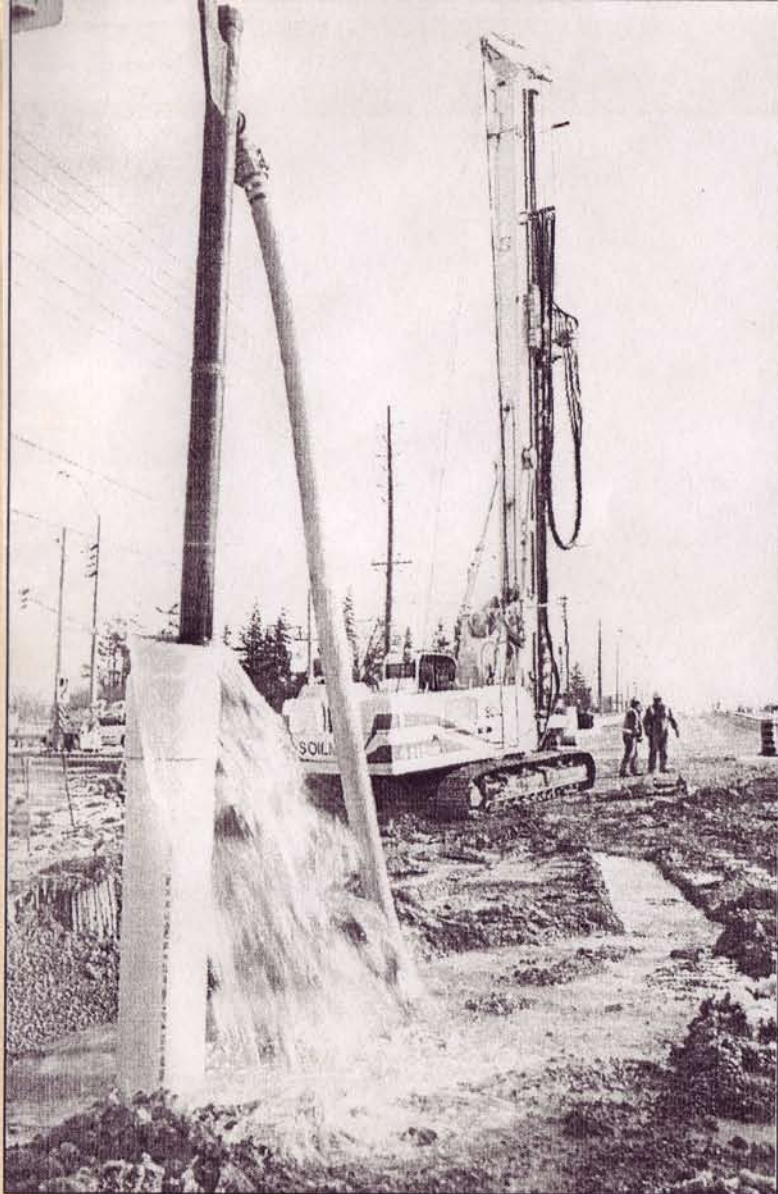
Work continues around the clock to repair a washed out sewer and watermain at the corner of Jane Street and Highway 7. Crews are draining the groundwater to assess what needs to be done from an open cut since tunneling is not feasible.

City of Vaughan emergency contractor, Clearway Construction, is now drilling holes to drain the water in an effort to get at the sewer and water main which have both ruptured and were part of the reason for the sinkhole's appearance.

"What we think — and we won't know until we really get in there — is that the sewer line was jacked through a liner plate casing and may not have been grouted properly when it was done 20 years ago," Macgregor said.

"That's what we suspect and we don't really know yet. But over the years we think that's allowed finings and material to wash through and erode the backfill

and then caused the ground to shift and move the sewer pipe which broke and just added more water to wash away more materials."

Finally, he said, more ground shifted and the watermain also ruptured, bringing in more water and the inevitable sinkhole.
